# Post-Fire Seeding & Mitigation on the Butte Fire

by David Gilpin<sup>1</sup>, Chris Swann<sup>2</sup>, and William Agnew<sup>3</sup>

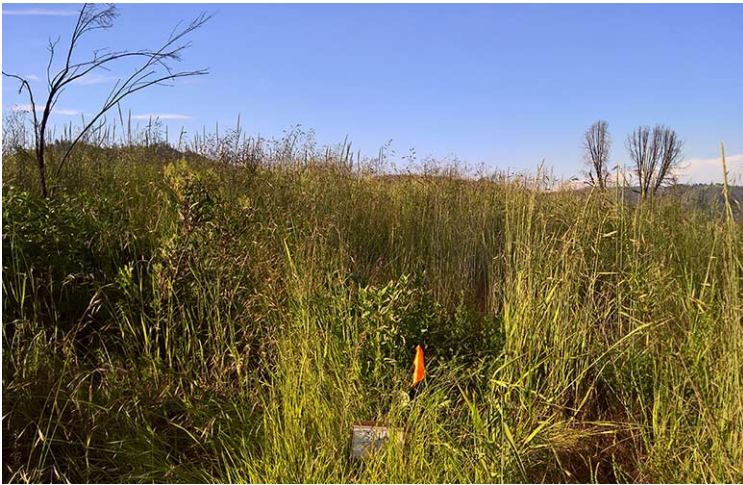
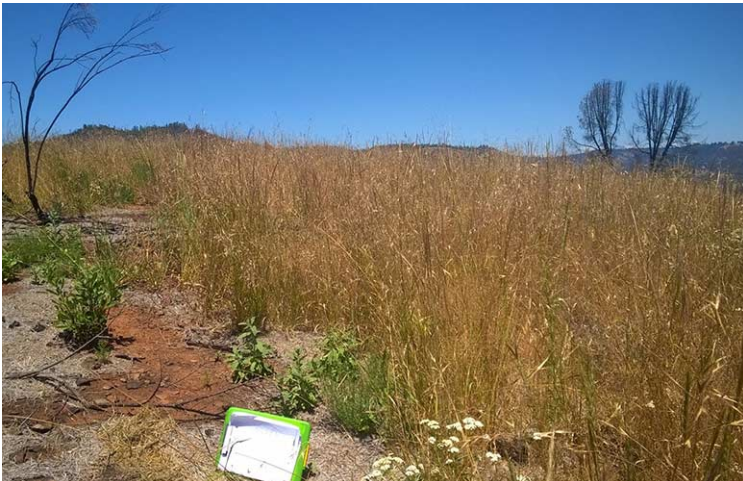
Figure 2. (left column, from top) Ocular canopy cover of the seeded rice straw treatment — Early Spring (April 16) 2016, Late Spring (June 5) 2016, and Spring (May 8) 2017.

canopy cover in April 2016 and 33.80% canopy cover in June 2016. Figure 1 shows herbaceous canopy cover, over time, from the initial sampling period (April 2016) through the May 2017 sampling date, for all treatments. The data indicated that the SS treatment consistently outperformed the other two treatments. In the latter part of the second growing season (May 2017), the SW treatment and untreated control treatment began to approach the cover performance of the SS treatments. Figures 2–4 shows estimated vegetation cover percentage establishment on each treatment over time.

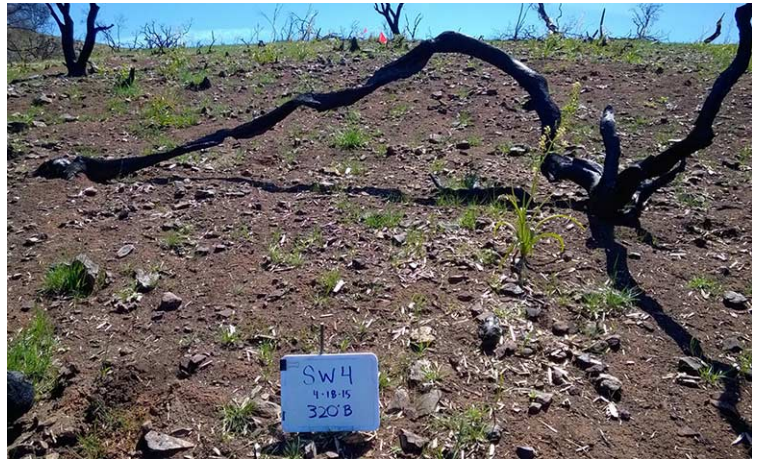
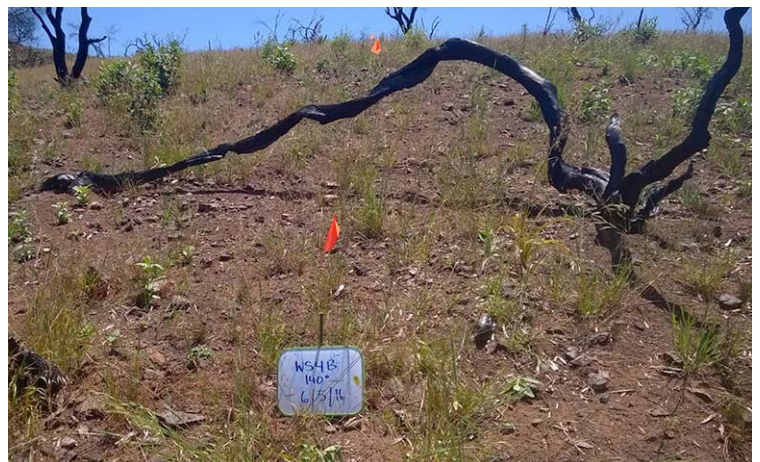
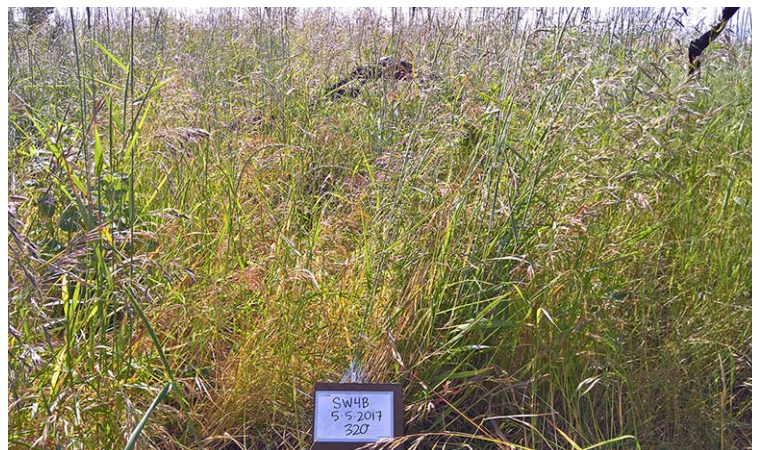
Figure 3. (right column from top) Ocular canopy cover of seeded wood chip treatment — Early Spring (April 15) 2016, Late Spring (June 6) 2016, and Spring (May 9) 2017.

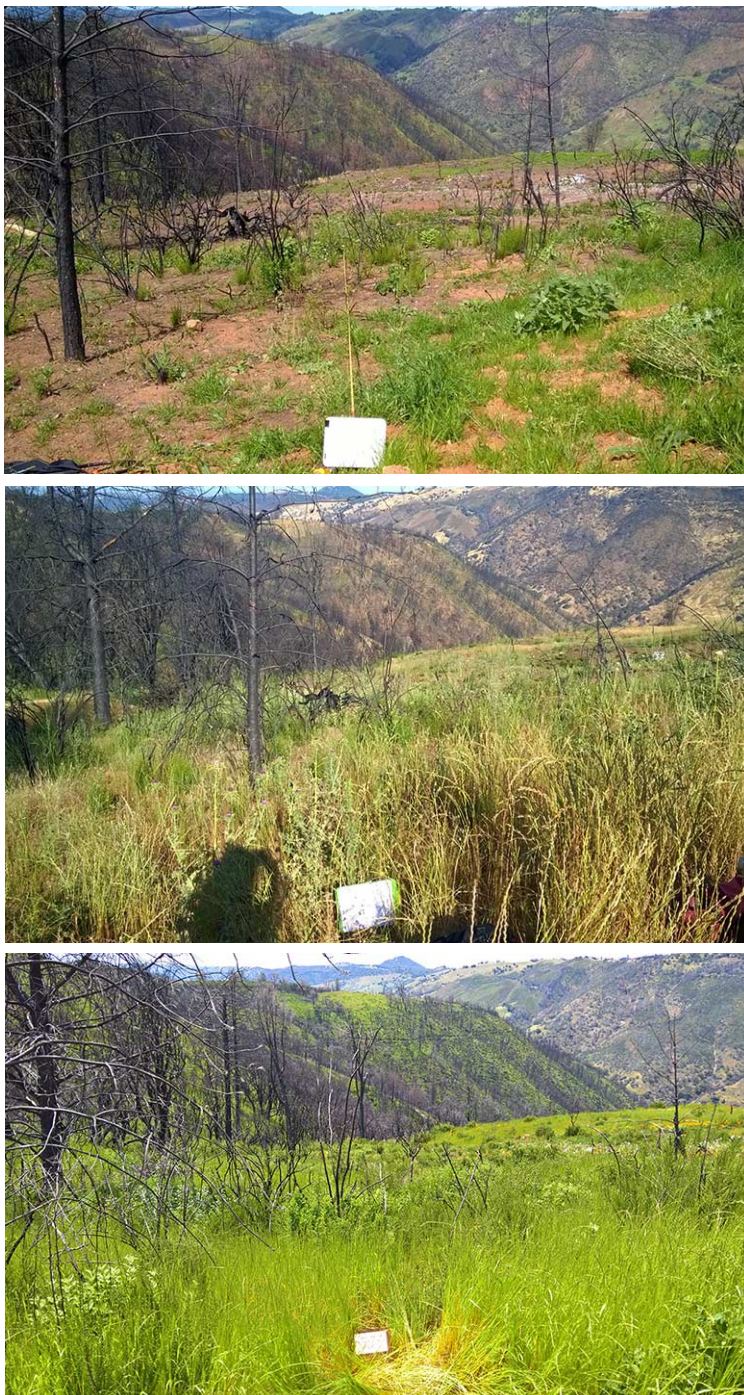
Figure 4. ( from top) Ocular canopy cover of the control — Early Spring (April 18) 2016, Late Spring (June 7) 2016, and Spring (May 10) 2017.

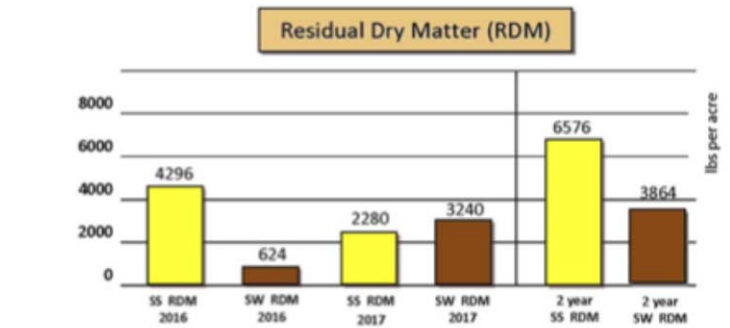
Figure 5. RDM for seeded rice straw (SS) and wood chip (SW) treatments by year and between years

Herbaceous vegetation production (aboveground herbaceous biomass) was more abundant on early seeded areas. The SS Treatments produced 4,296 lbs RDM/acre in 2016 (Figure 5). The wood chip treatments produced 624 lbs RDM/acre. To reiterate, the SS treatment was completed in late October (24–27) 2015 and the SW treatment was completed later, in January (25–29) 2016. The data suggests that early seeding and timely precipitation are directly related to the amount of plant biomass produced in this study area. Other collateral benefits include enhanced habitat cover and increased forage value at the site.

In 2017, RDM production in the SS treatments decreased to 2,280 lbs/acre. In the SW treatment, RDM production was more than five times the 2016 production levels, outperforming the SS with a calculated 3,240 lbs RDM/acre. Total RDM over the two-year period on the seeded straw was 6,576 lbs RDM/acre and 3,864 lbs RDM/acre on the seeded wood chip plots (Figure 5). The data indicate that perennial grasses, mostly California brome and Blue wildrye, returned strongly from their crowns and provided significant cover in the second year. The authors suspect that the total RDM of the wood chip site may continue to trail the seeded straw treatment for years due to nutrient loss associated an estimated loss of 78 tons/acre over the initial two recovery years.
